Fountain with boulder in clear water

Initial situation

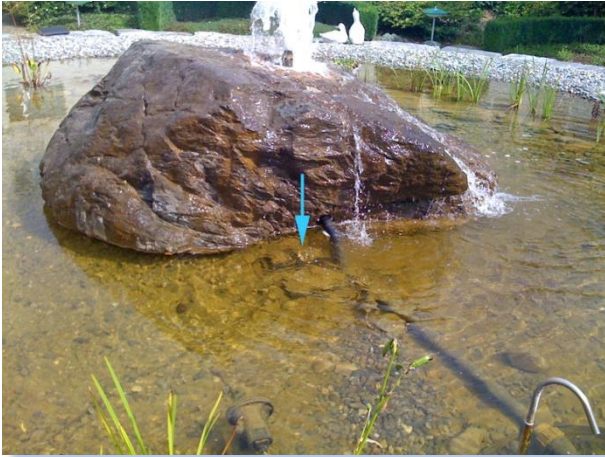
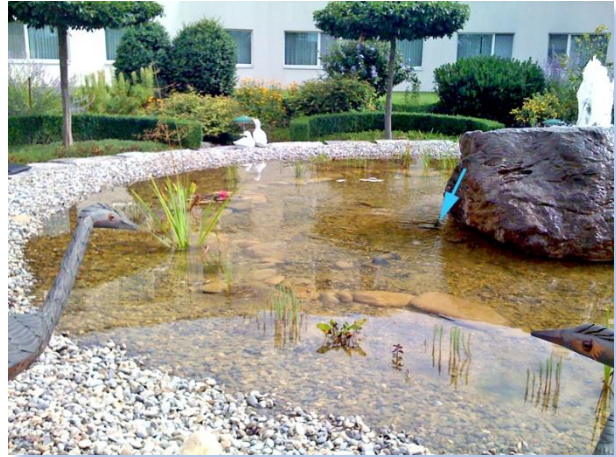
Click generator positions

With a range of 10 meters each, two G-Sonic 10 algae-free devices were used for a stronger click sound distribution in the shallow water.

- Installation of two G-Sonic 10 algae free devices to ensure 360° click sound for the well.
- A cleaning of the well to remove the settled nutrients.
- Refilling with nutrient-poor tap water.

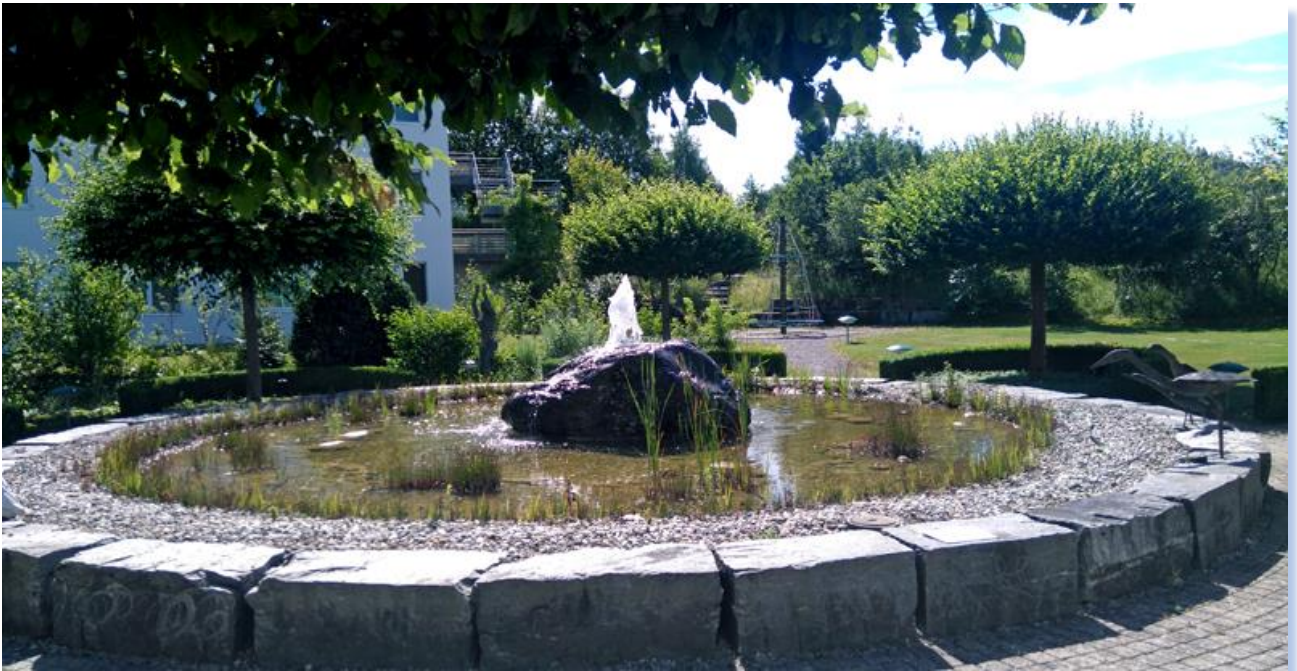
The algae-free devices are still successfully in use today. The maintenance costs of the well have been massively reduced. The well is cleaned once a year to remove the accumulated sediment.
